Original Article

Comparison of shear bond strength of two veneering ceramics to zirconia

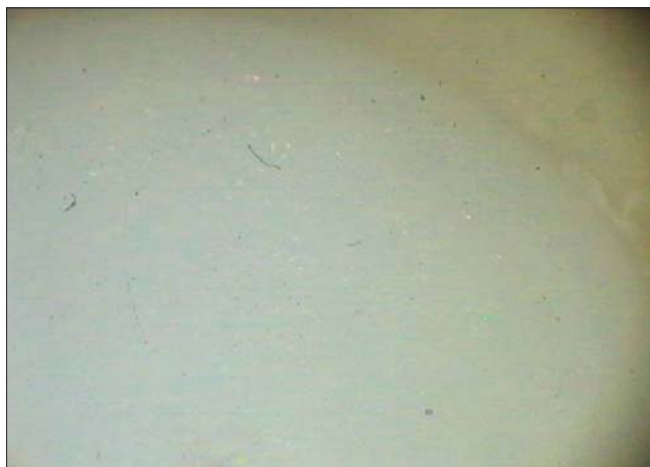
**Figure 2:** Adhesive failure

Table 3 summarizes the mean values and standard deviations of SBS for the tested zirconia ceramics and veneering ceramics and presents the fracture analysis results in percentage. T-test revealed that there is no significant difference between two groups ($P = 0.551$). Upon examination under the stereomicroscope ($\times 36$), the Biodenta group exhibited mostly adhesive failures [Figure 2]; whereas, the Cercon group showed mixed cohesive/adhesive failures [Figure 3].

In the present study, specimens of Biodenta group revealed predominantly adhesive failure between the zirconia cores and their veneering ceramics, but in Cercon Group, the most failure pattern was combined. Adhesive failure does not occur in the presence of a good bond between compatible ceramic core and veneering materials,^[25] so it seems that the cohesive strength of Biodenta ceramics was higher than the bond strength between Biodenta zirconia and the veneering ceramic. In Cercon group the weakest link was the veneering ceramic. Some studies showed that the bond strength of veneering ceramics to zirconia core seems to be higher than the SBS of the ceramic itself. In SBS tests with zirconia/veneering ceramic composites, adhesive failures were the least failure modes seen in these studies,^[25,30,31,33] whereas others claimed that the SBS of veneering ceramics were higher than SBS between core and veneering ceramics and the failure mode observed was mainly combined as adhesive at the interface and cohesive in the veneering ceramic.^[28,34,41,42]

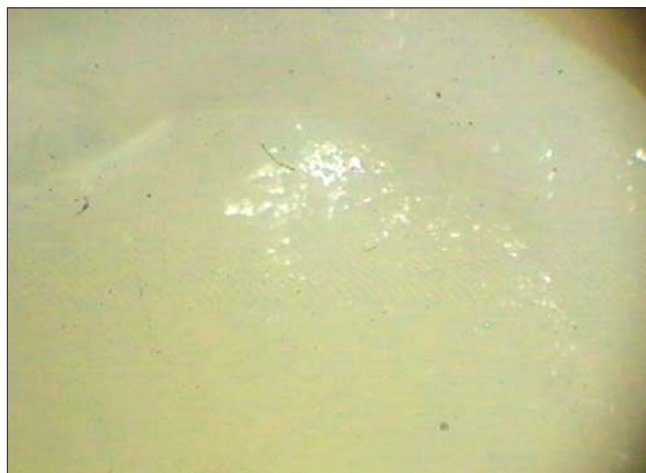
**Figure 3:** Combined (adhesive and cohesive) failure
